Re: Linnton Plywood Association Facility  
10504 NW St Helens Road, Portland OR  
ECSI No. 2351

**State of Oregon**  
**Department of Environmental Quality**  
**Memorandum**

**Subject:** Staff Report for Completion of Pre-Remedial Investigation  
Linnton Plywood Association/Columbia River Sand & Gravel Facility  
Portland, Oregon  
ECSI – 2351 & 2373

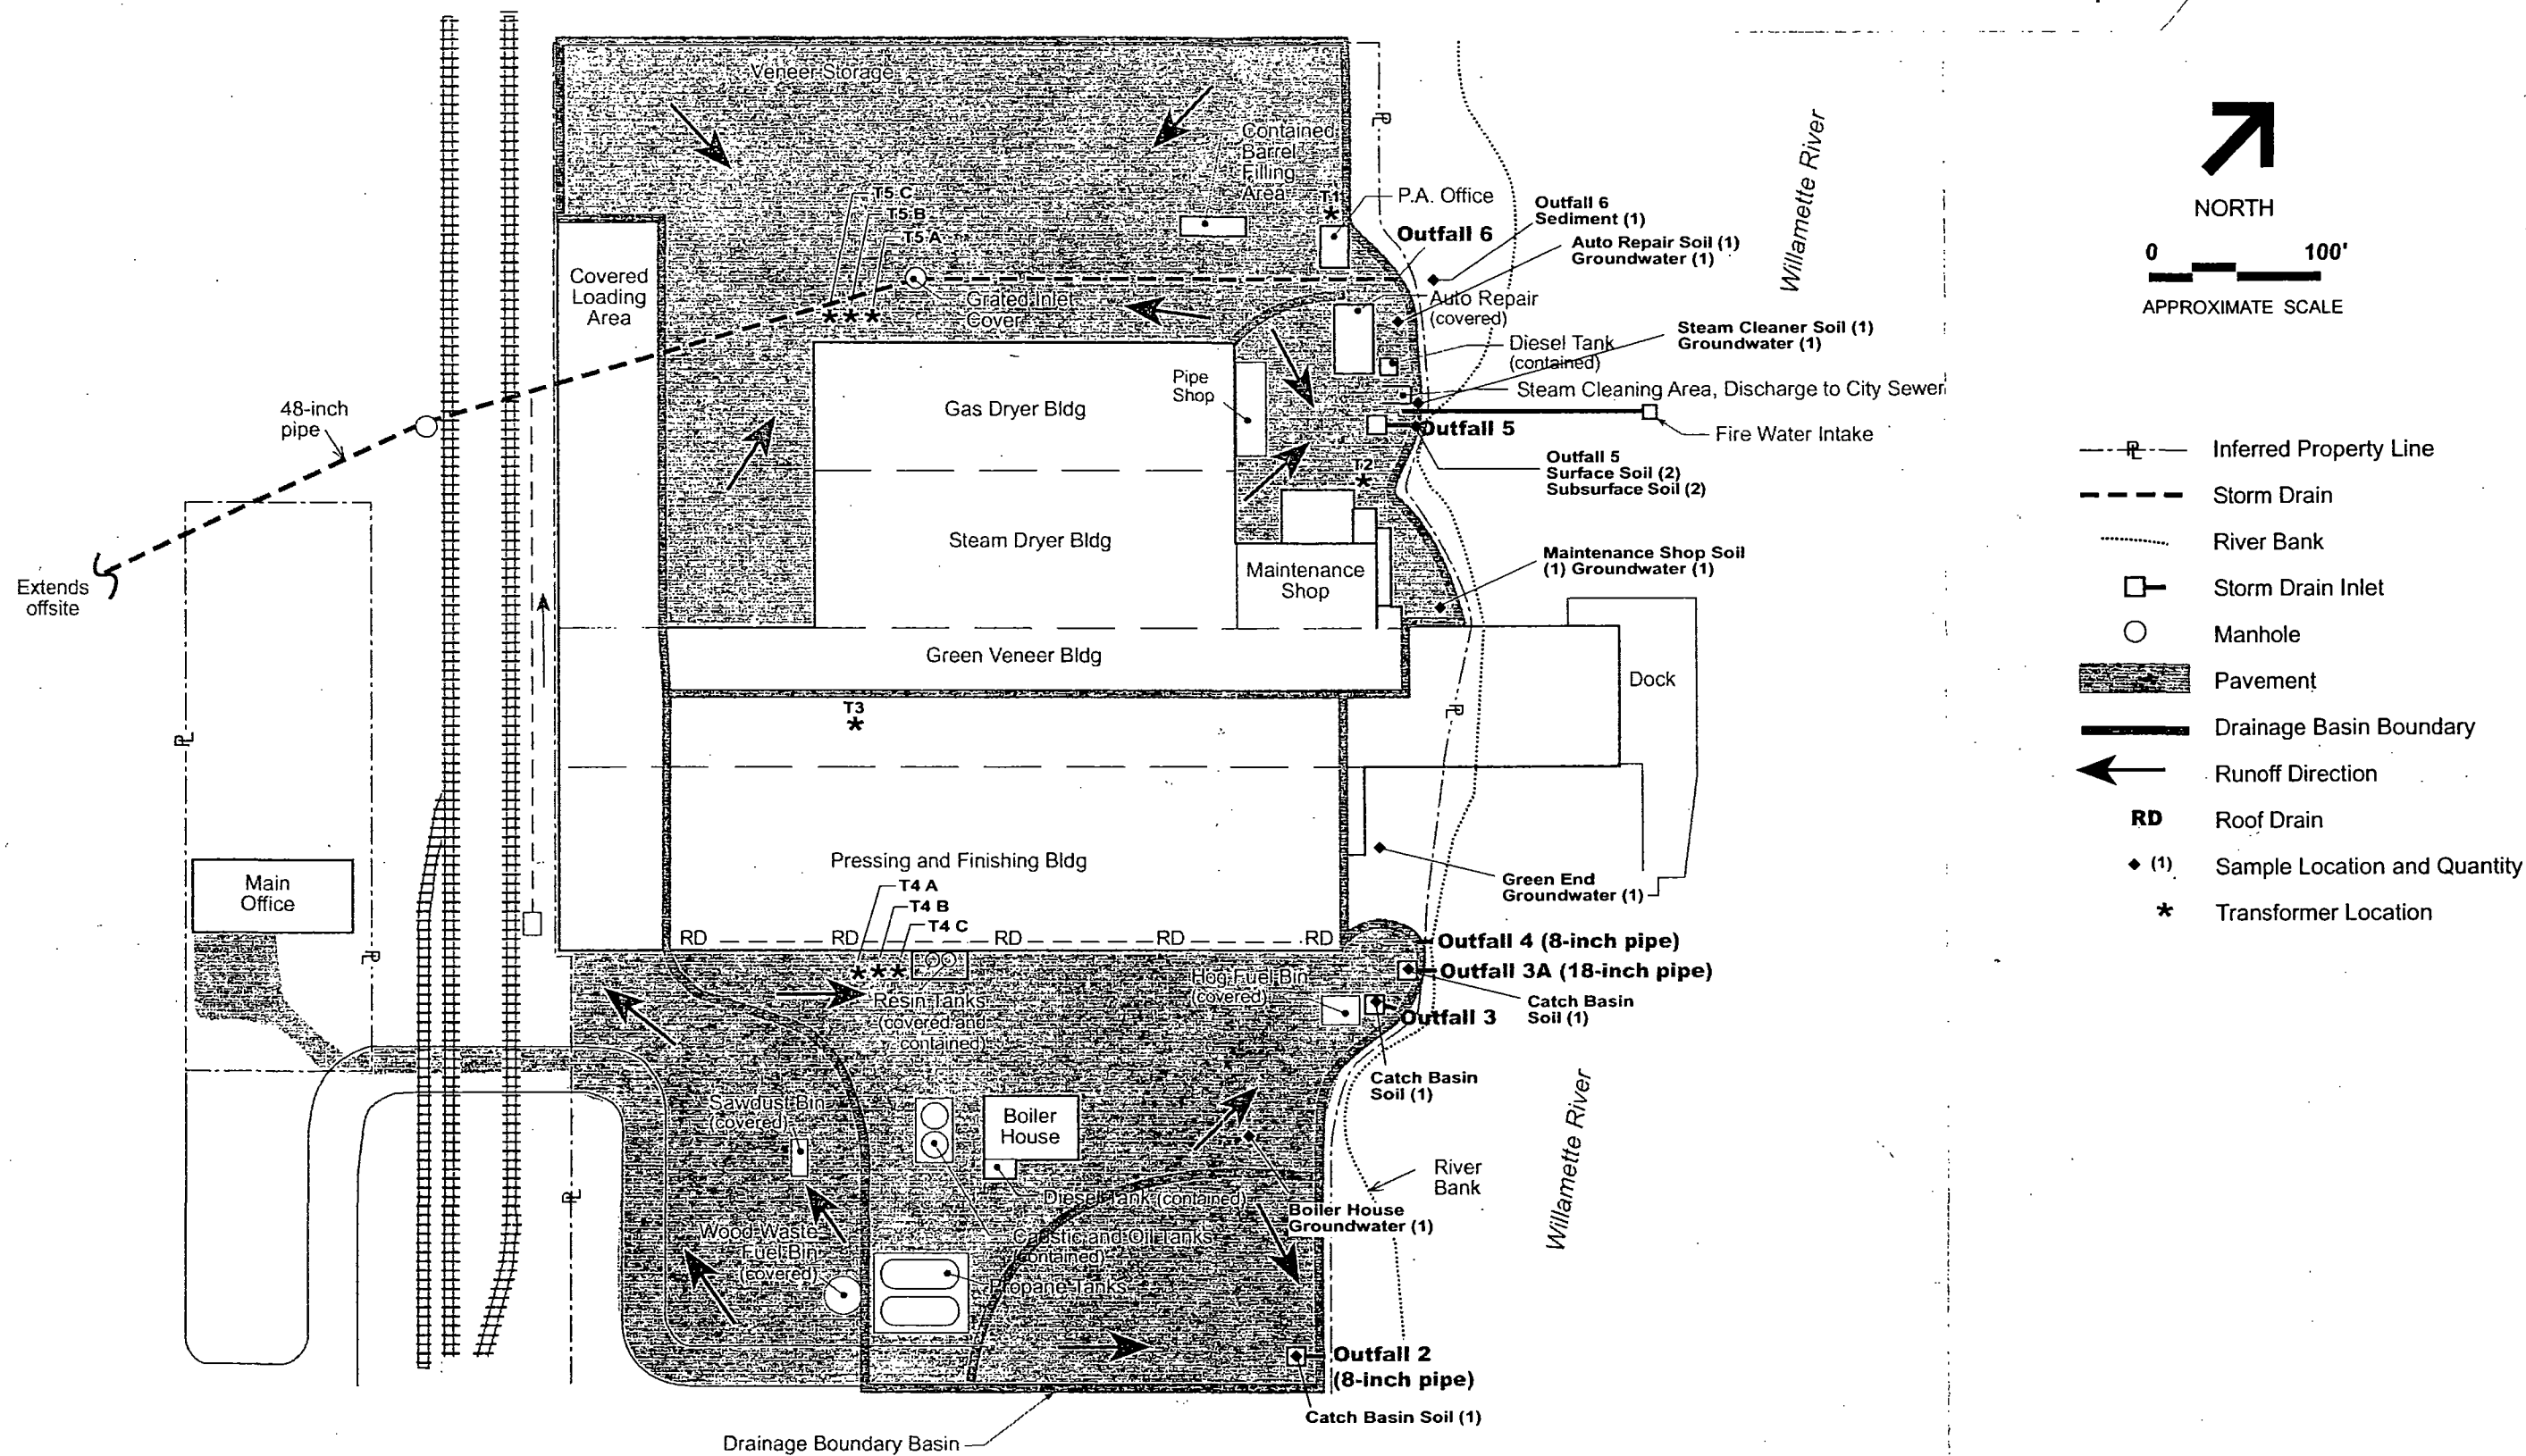
**FIGURE 2**  
**Sampling Locations**

Initial samples of Outfall 5 surface soils (at base of outfall discharge area) contained petroleum (primarily diesel-range hydrocarbons at 1,270 to 1,820 mg/kg), low levels of chlorinated hydrocarbons, and elevated metals. LPA proposed further evaluation of Outfall 5 after removal of visibly stained material (see Source Area Removals, below).

The soil samples collected at Outfall 6 (October 2001 and October 2002) to evaluate potential contribution via the stormwater pathway contained PAHs, cadmium, copper and lead at concentrations above DEQ Level II sediment SLVs and/or background concentrations for terrestrial soils. Sediment samples collected from Catch Basins 2, 3, and 3A contained copper above DEQ Level II sediment SLVs. Isopropyltoluene and toluene were detected at low concentrations in Catch Basins 3 and 3A. There are no ecological toxicity criteria to evaluate these compounds in a sediment matrix. PCBs were also detected at low concentrations, below the DEQ Level II sediment SLVs.

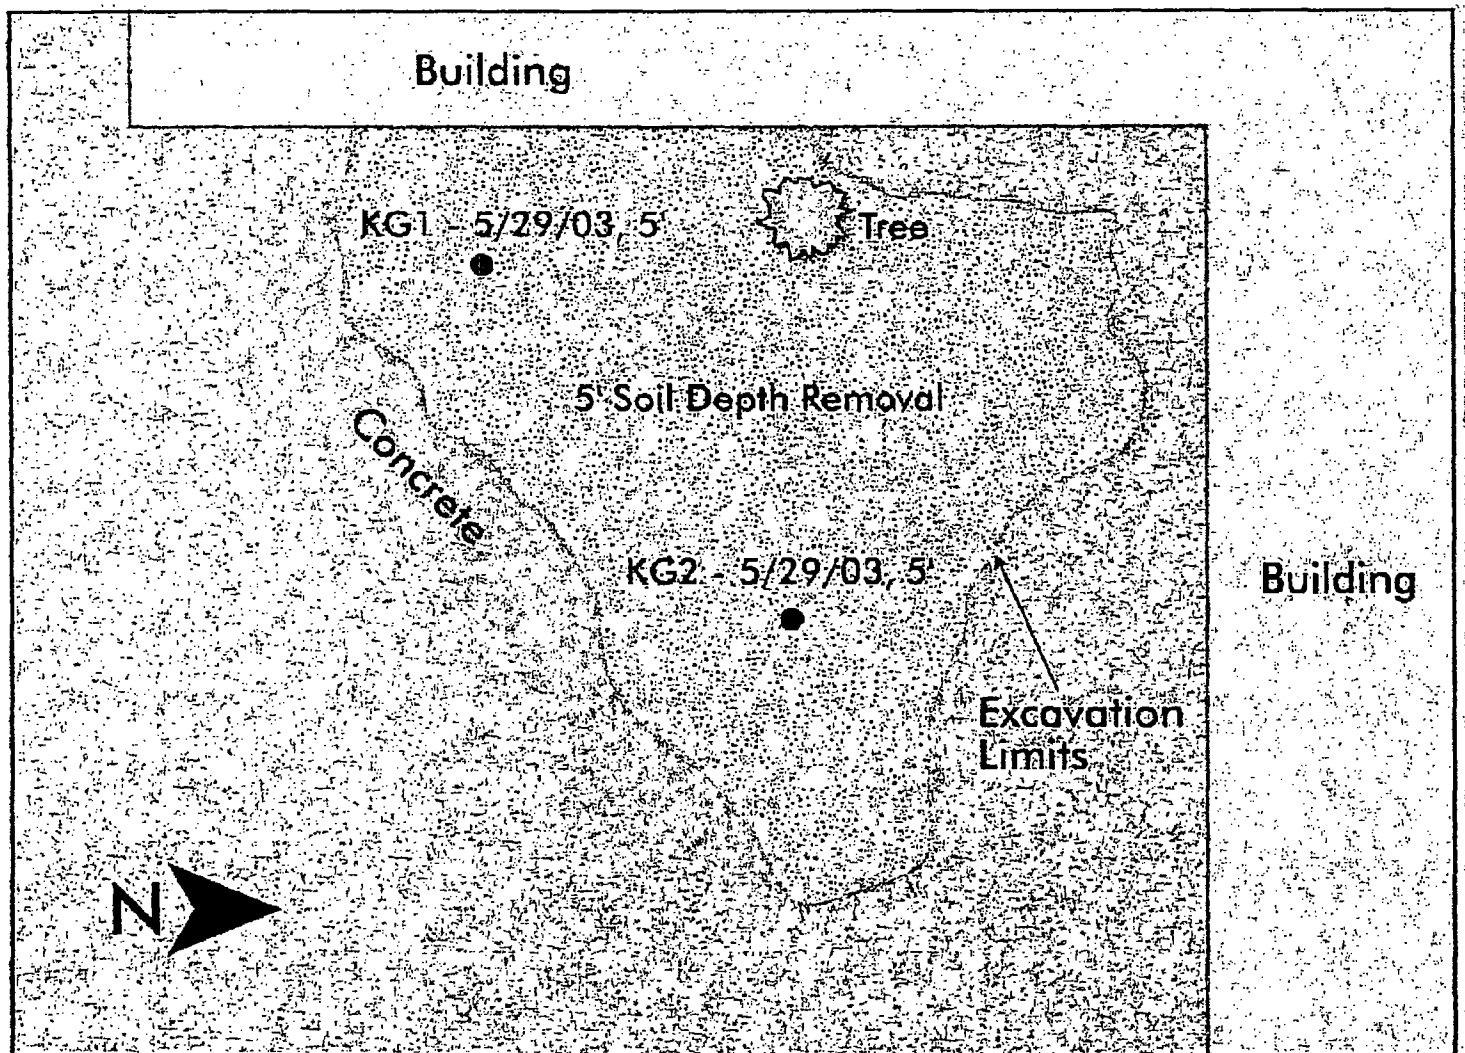
**Figure 5**

The knife-grinding debris pile was located beneath a small pipe outfall from the eastern edge of the pressing and finishing building (Figures 4 and 5). A distinct cone-shaped pile approximately 8 cubic yards in volume was present beneath the end of the pipe. When the material was tested for site-specific COIs, it was found to contain high concentrations of chromium and low levels of copper and lead. Through toxicity characteristic leaching procedure testing, chromium was found to be non-leachable and therefore it is not considered a characteristic hazardous waste under the Resource Conservation and Recovery Act. Diesel and heavy oil-range petroleum hydrocarbons were also detected in a sample of the material. The above-ground portion of the material was removed in 2002, and the remaining material was removed in May 2003. Confirmatory samples collected after removal of the pile were analyzed for metals (chromium, copper, and lead), semi-volatile organic compounds (SVOCs) and TPH-Dx. Diesel/oil range hydrocarbons were detected at low concentrations (128 mg/kg) in one of the two confirmatory samples, and metals and SVOCs concentrations in the confirmatory samples were below available sediment PECs and (Table 3).

**Figure 5: Knife-Grinding Area  
Soil Removal Area and Confirmation Sample Locations**

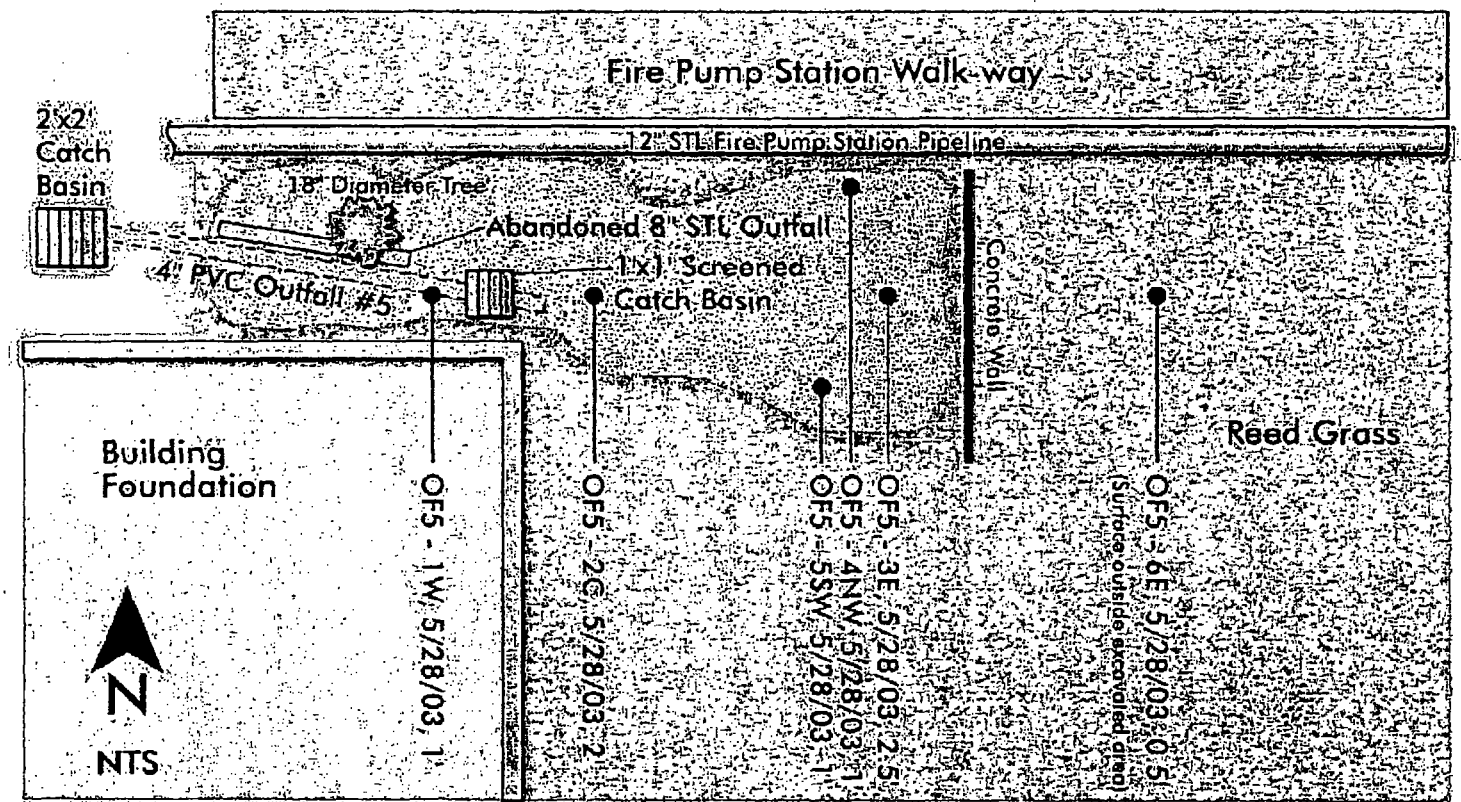
Figure 6

Soil collected from the Outfall 5 area in October 2001 was found to have elevated metals (cadmium, chromium, copper, lead and zinc), chlorinated hydrocarbons including dichloroethene, tetrachloroethene (PCE), methylene chloride, and phthalates (Table 2). In May 2003, approximately 9 cubic yards of soil were removed by loosening the soil with a shovel and vacuuming the material to a truck (Figures 2 and 6). Confirmatory samples collected after removal of impacted soils were analyzed for SVOCs, volatile organic compounds (VOCs), metals (cadmium, chromium, copper, lead and zinc) and diesel-range petroleum hydrocarbons. Initial confirmatory samples indicated that with the exception of a single sample (sample OF5-2C located immediately beneath the outfall opening) all contaminant concentrations were below available sediment PECs. Sample OF5-2C contained a lead concentration of 244 mg/kg, approximately twice the sediment PEC of 128 mg/kg. Additionally, diesel/oil-range petroleum hydrocarbon concentrations varied between not detected and 2,010 mg/kg. However, neither VOCs nor SVOCs (typical risk-driving petroleum hydrocarbon constituents) were detected in any of the confirmation samples (Table 3). Furthermore, the sample testing 2,010 mg/kg of diesel-range petroleum hydrocarbons (sample OF5-6E) was collected 0.5 feet bgs, and since the excavation has been backfilled, this residual contamination is now below ground surface and unavailable for contact or transport.

Outfall #5 Removal Area and Confirmation Sample Locations

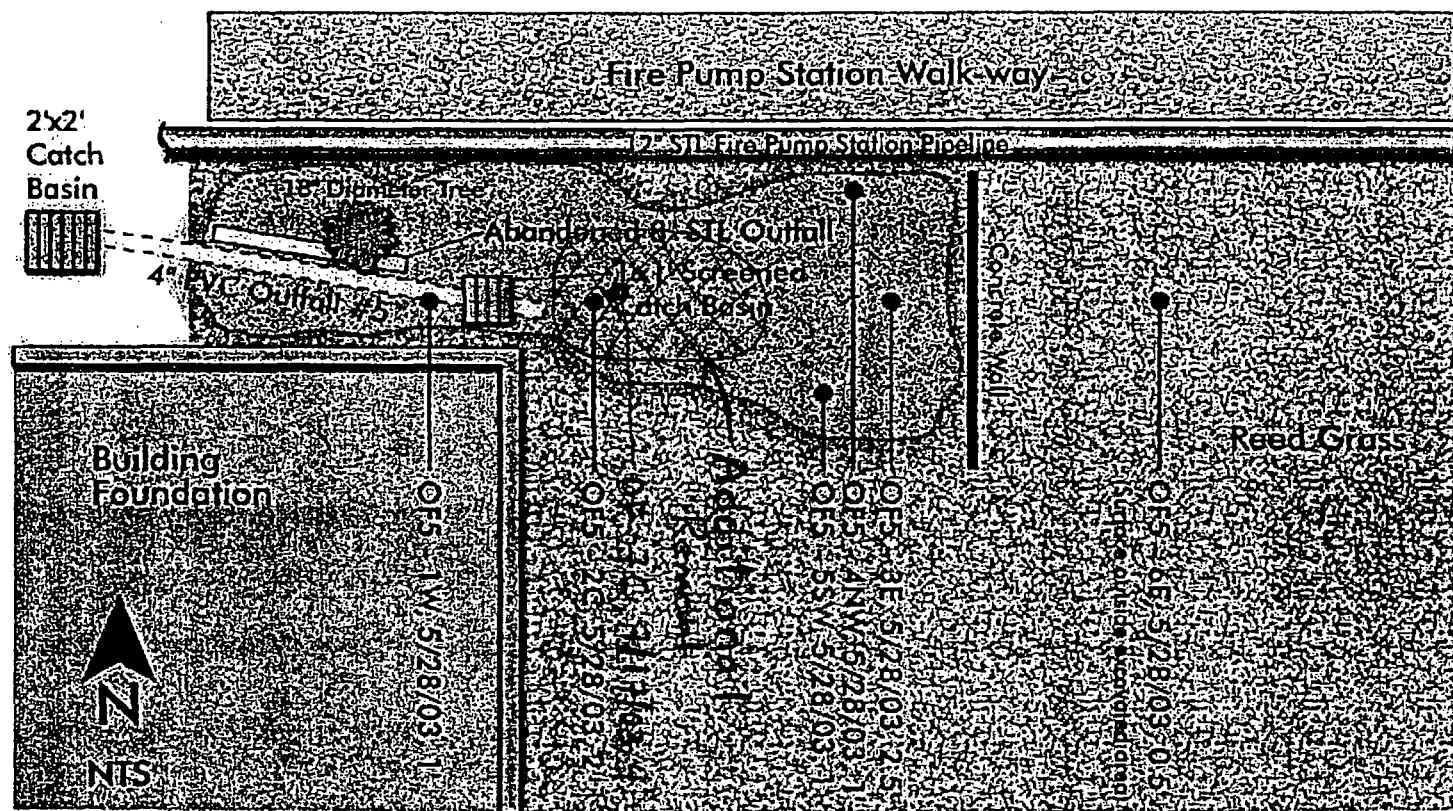
Figure 7

A second round of excavation was performed in July 2003 to remove approximately ½ cubic yard of material directly beneath the outfall (Figure 7). A confirmation sample collected

after removal of the material had a lead concentration of 69.4 mg/kg, or approximately ½ the applicable sediment PEC.

Outfall #5 Removal Area and Confirmation Sample Locations
